**TRANSPORTATION SCIENCES CENTER
ACCIDENT RESEARCH GROUP**

**CALSPAN ON-SITE AIR BAG DEPLOYMENT INVESTIGATION
CALSPAN CASE NO. 95-21
VEHICLE: 1995 DODGE CARAVAN
LOCATION: MARYLAND
CRASH DATE: [REDACTED] 1995**

This on-site investigation focused on a child fatality that resulted from the deployment of the passenger side air bag in a 1995 Dodge Caravan. The 7 year old female child occupant was the right front passenger in the Caravan that was occupied by the 43 year old male driver and two additional child occupants seated in the second seat of the seven passenger vehicle configuration. On an approach to a four-leg intersection, the driver was momentarily distracted and failed to detect a red signal phase. He braked, however, the full frontal area of the Caravan impacted the left side area of a 1992 Chevrolet Lumina APV which resulted in deployment of the Dodge's supplemental driver and passenger side air bags. The right front child occupant was out of position in a forward direction as a result of the pre-crash braking force and within a close proximity to the passenger side air bag module assembly. The deploying air bag contacted the underside of her chin, face, anterior neck, an

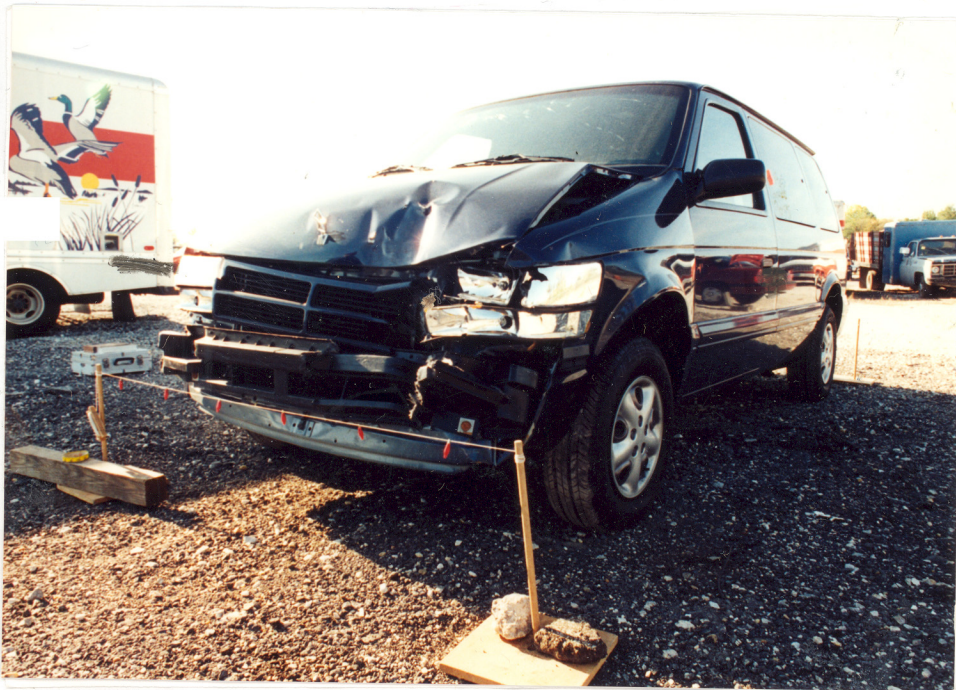
14. Left front three-quarter view.

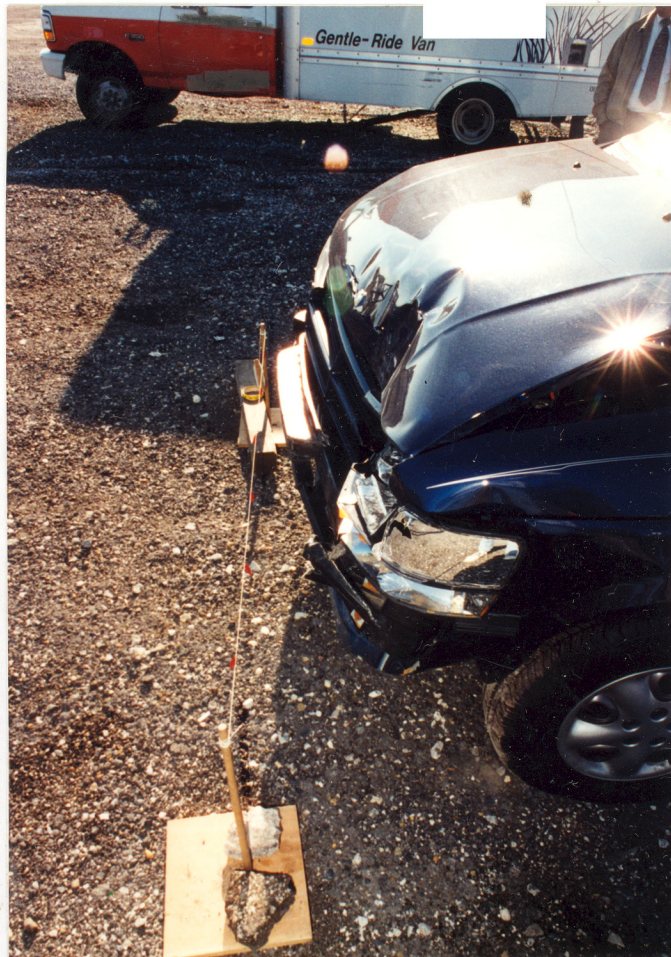
15. & 16. Profiles views of maximum crush at the **left front bumper corner**.

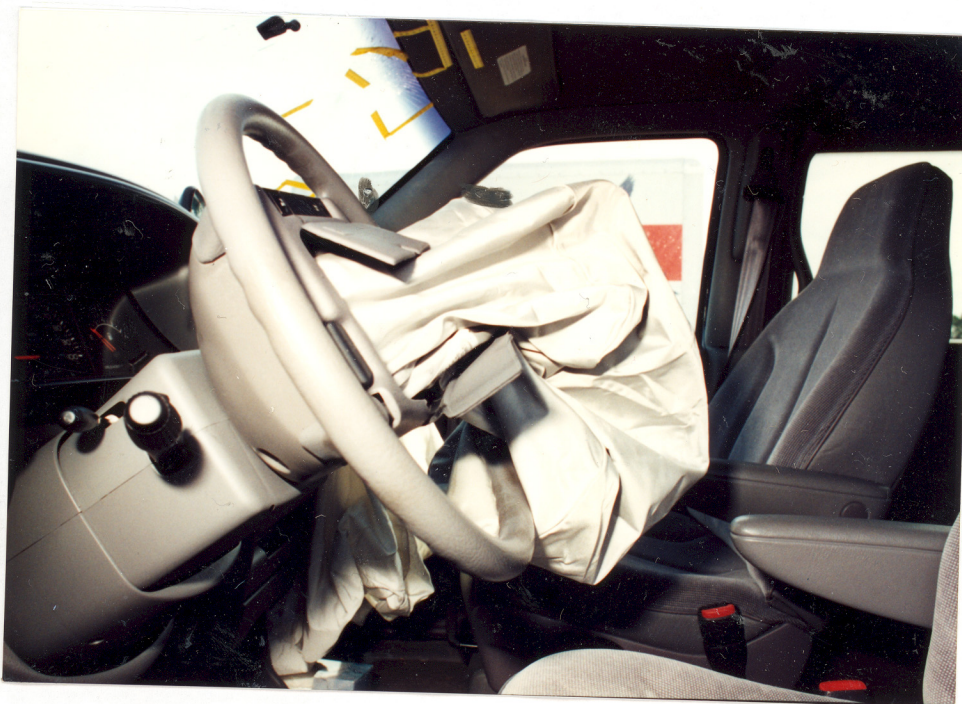
25. Perpendicular view of the symmetrical driver side air bag module cover flaps.

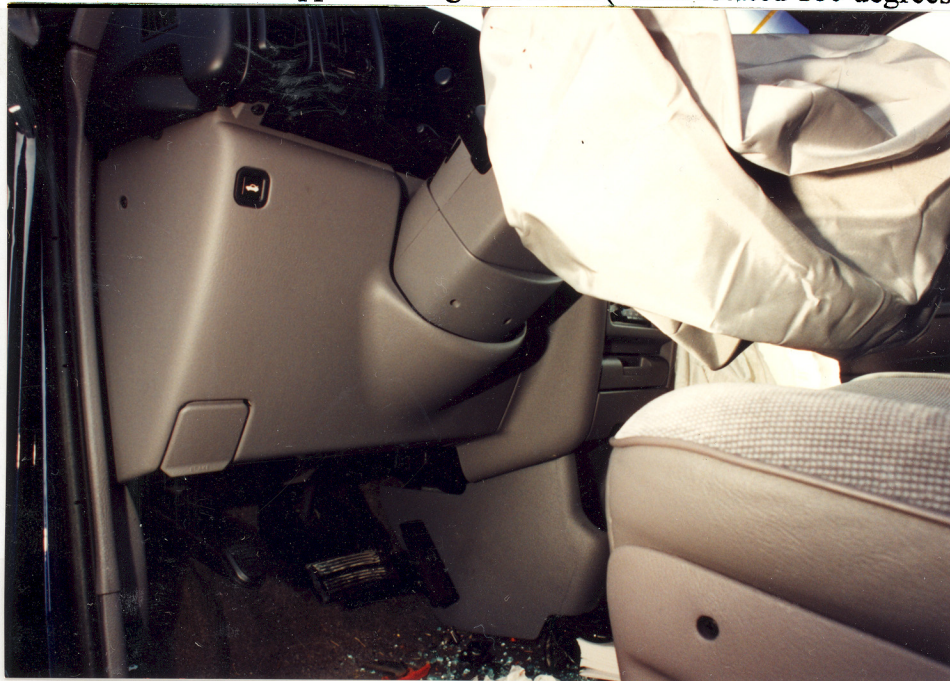
The driver's left knee probably contacted the left side of the plastic knee bolster. There was no evidence of contact to the exterior surface of the bolster, however, upon removal of the bolster to inspect the energy absorbing steering column, the lower left outboard mounting bracket of the bolster was fractured at the screw position. This damage could have resulted from knee loading or during the assembly process of the vehicle.

30. Driver's side knee bolster and exposed steering column assembly.

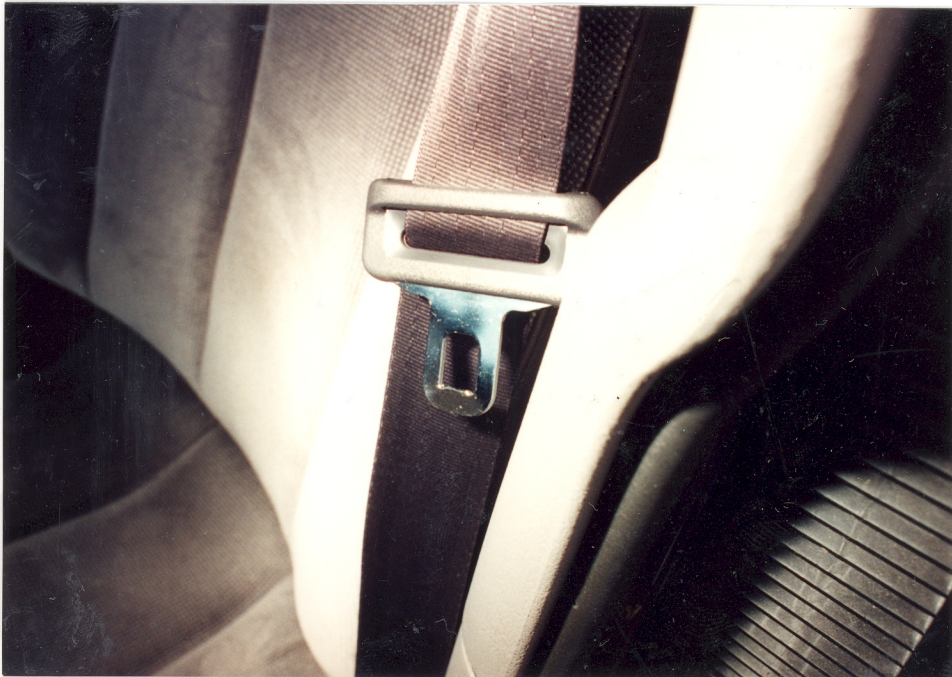
34. Driver's side latchplate; minimal routine usage wear marks.

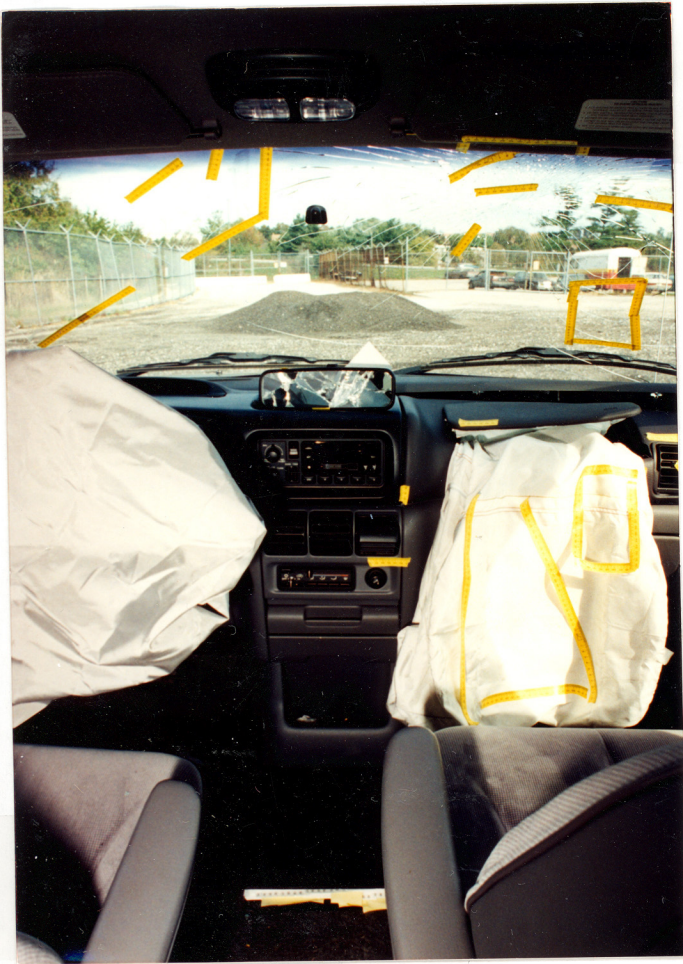
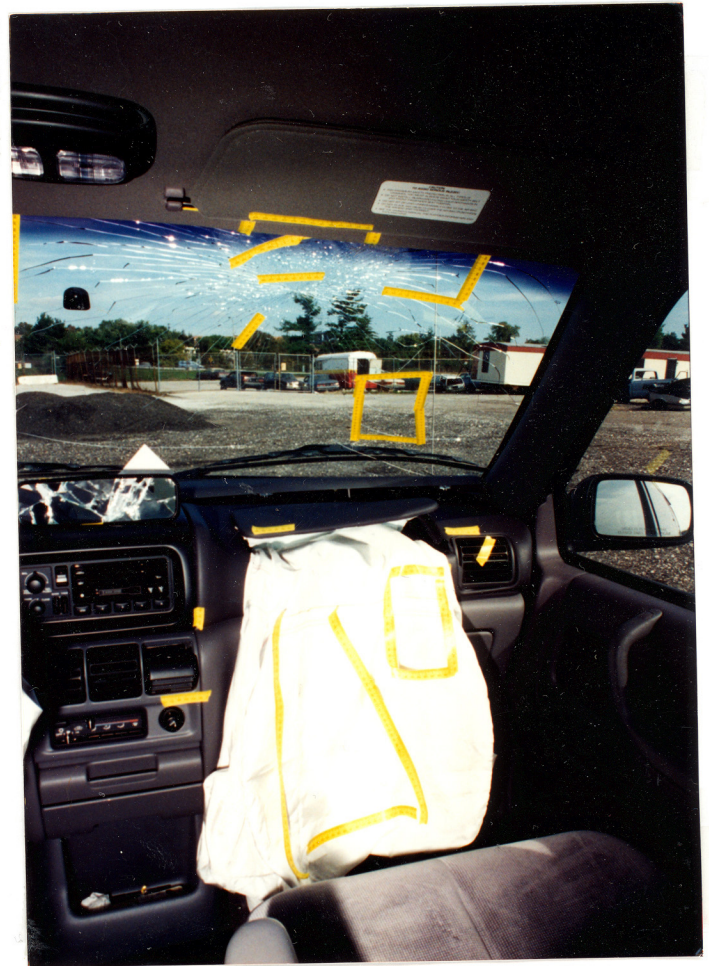
37. & 38. Overall views of the frontal interior surfaces, deployed air bags, and contact points.

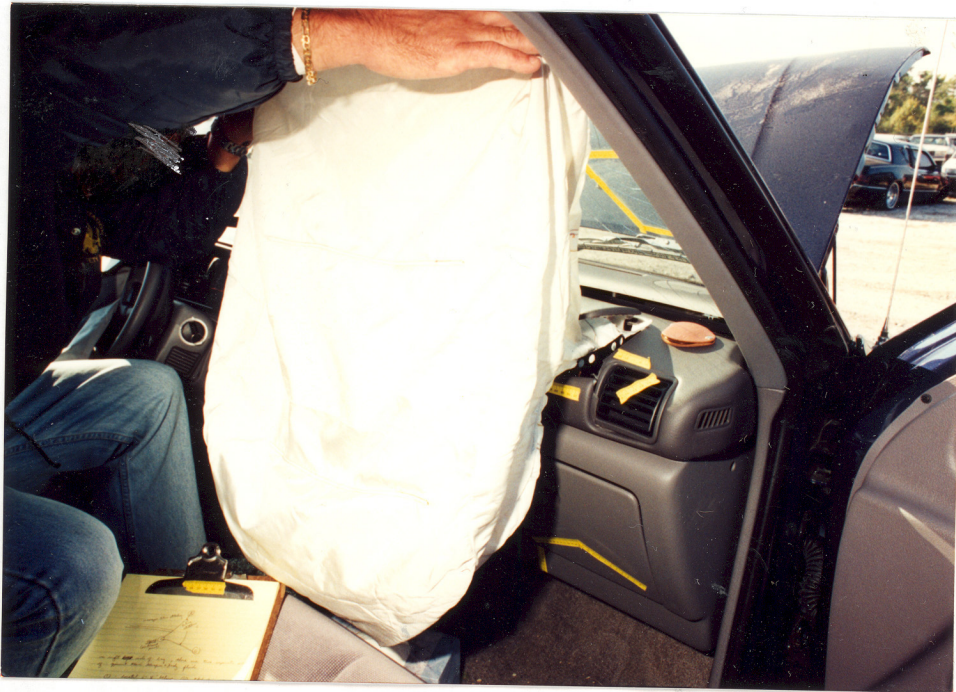
39. Overall view (expanded) of the passenger side air bag.

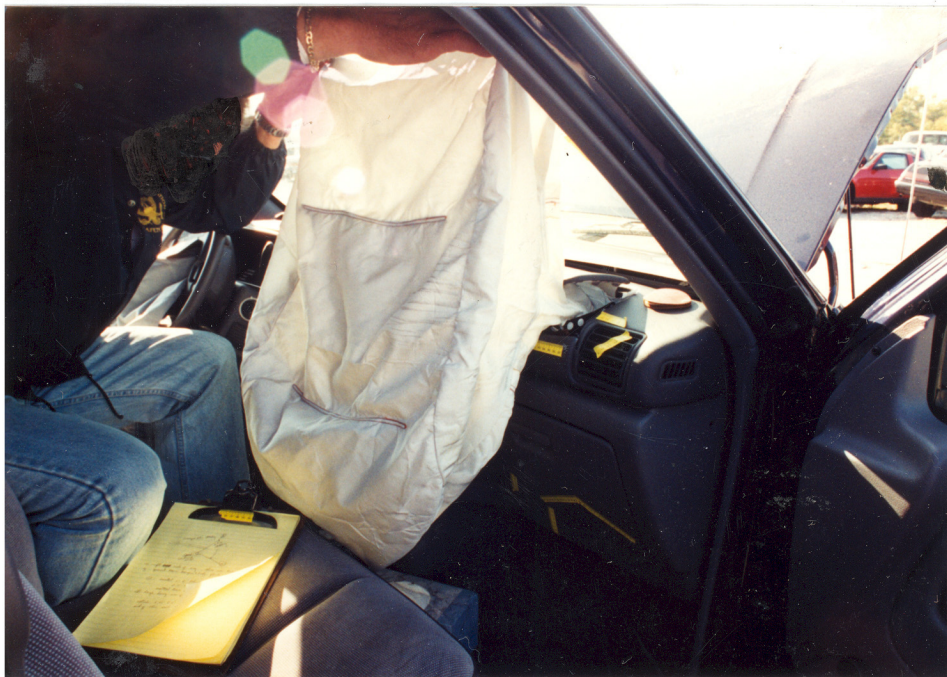
40. Horizontal vinyl transfers on the right side of the passenger side air bag.

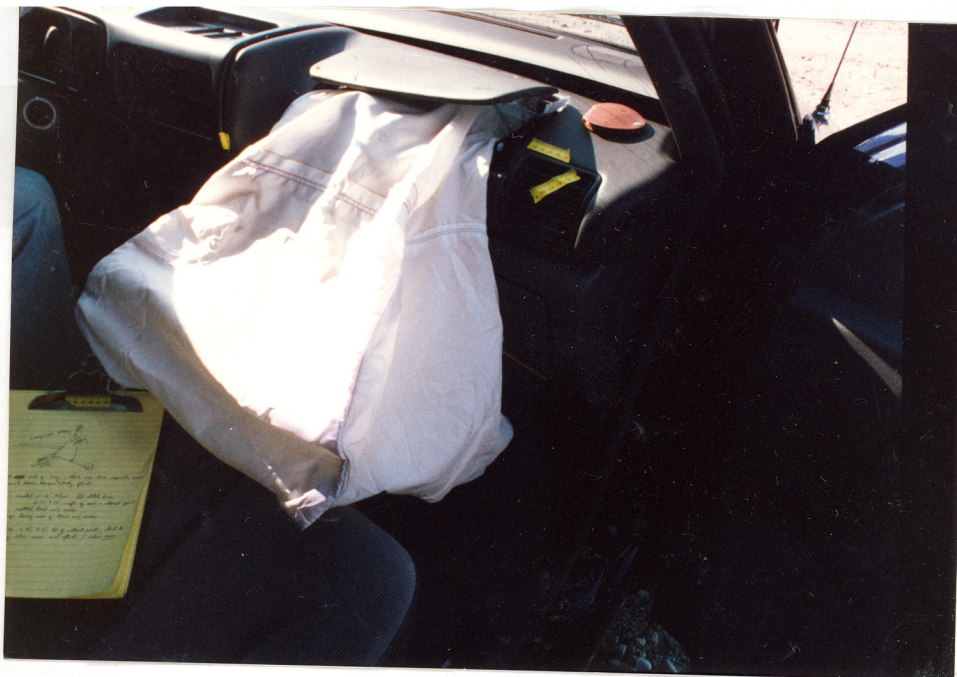
41. Top and right side view of the passenger side air bag.

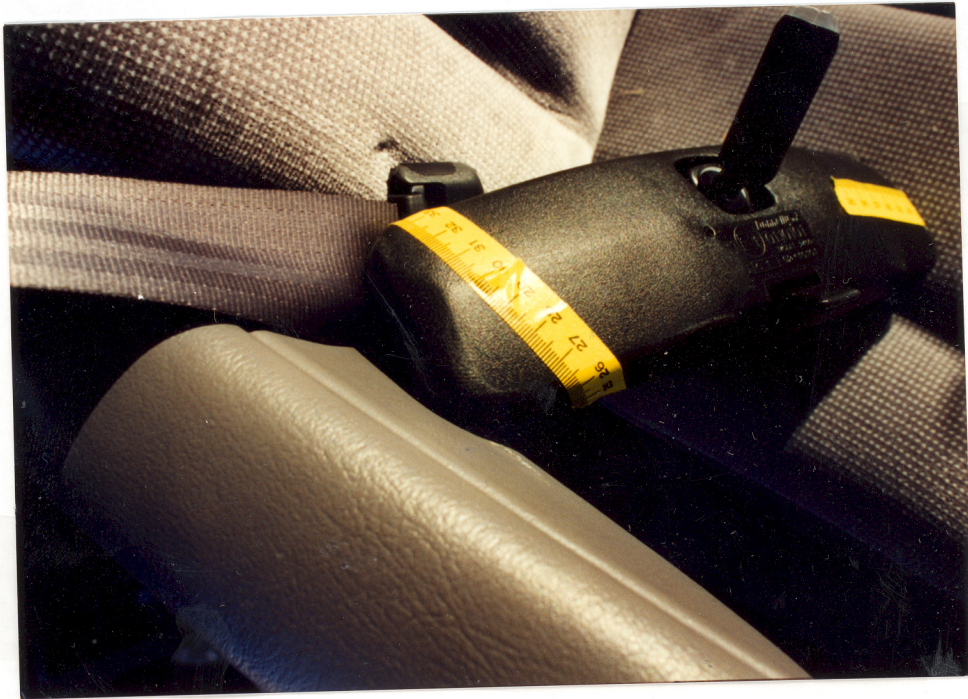
63. Close-up view of the fabric transfer.

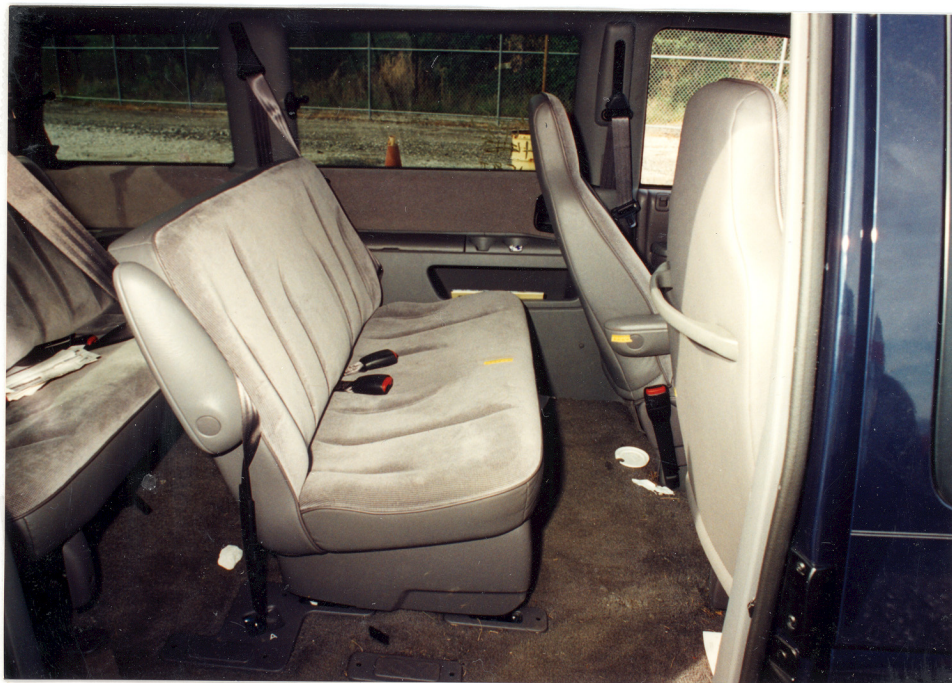
The child occupant was displaced rearward and came to rest lying across the interior of the vehicle with her head resting on the inboard armrest of the driver's seat. Her pelvis and lower extremities remained on the right front seat cushion with the lap belt positioned around her waist. Her final rest position was confirmed by a blood transfer noted to the armrest and from statements of the rear seated occupants.

66. Second seat of the Dodge Caravan and final rest position of the right front passenger.

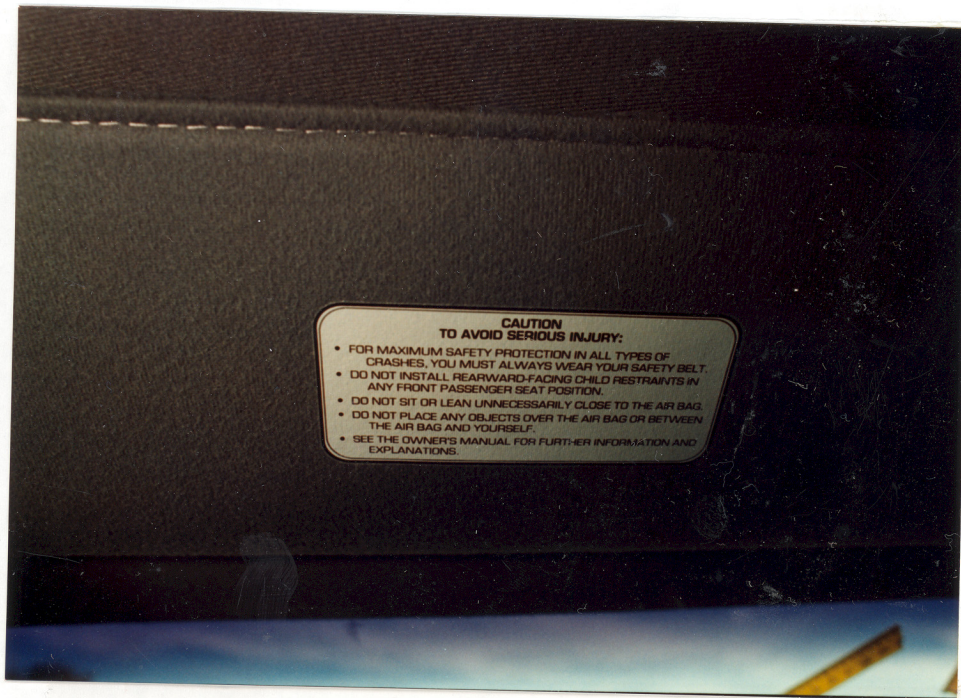
69. Warning label on the right front sunvisor of the Dodge Caravan.

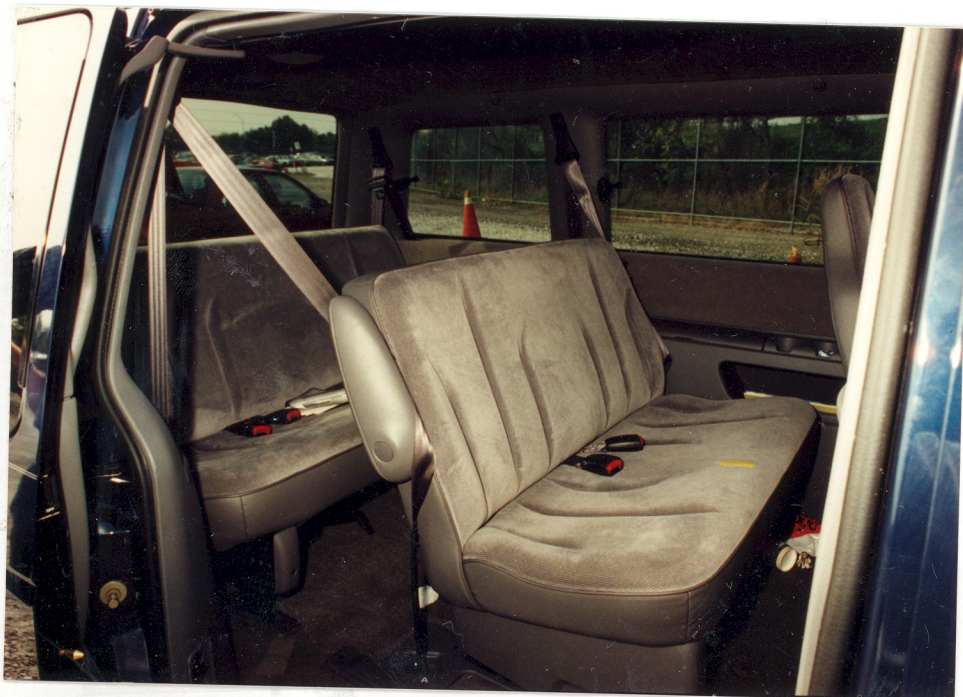
70. Second seat and manual 3-point lap and shoulder belts.

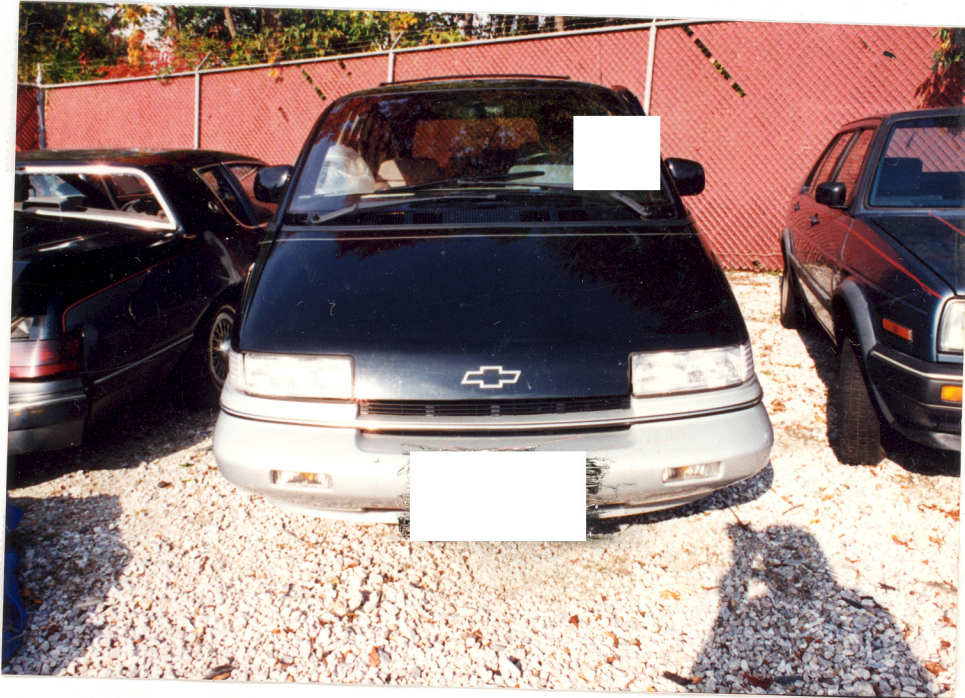
74. Frontal view of the 1992 Chevrolet Lumina APV.

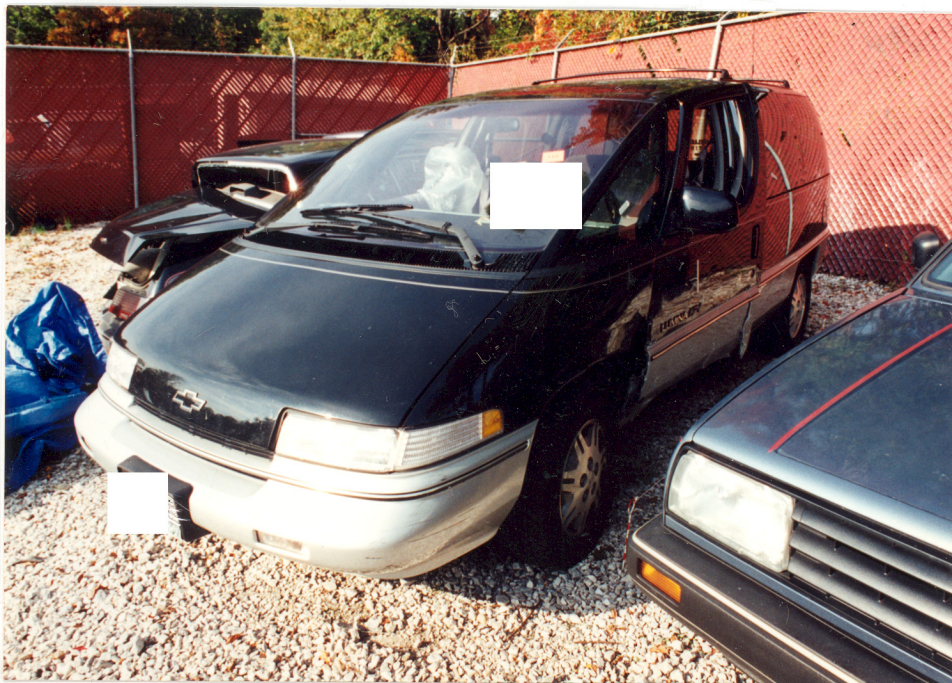
75. Left front three-quarter view of the Lumina APV.

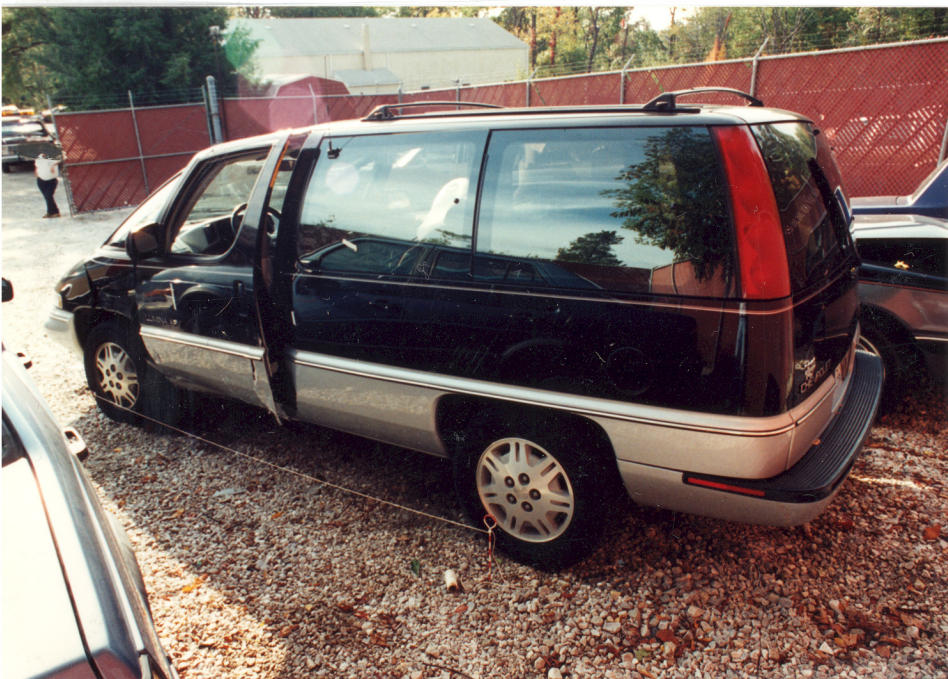
77. Left side view of the Lumina APV.

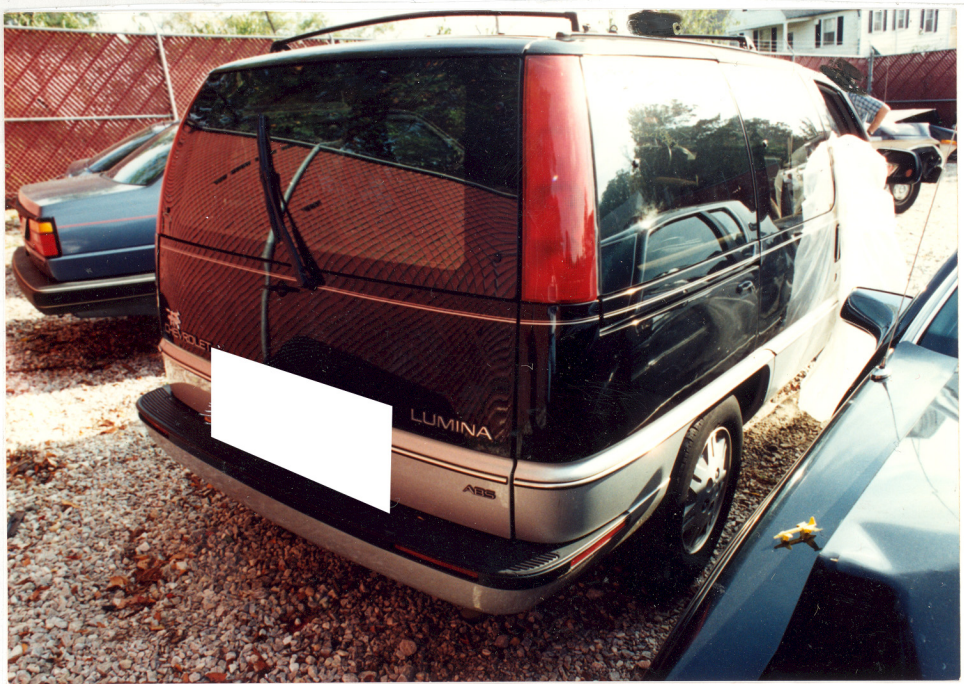
80. Right rear three-quarter view of the Lumina APV.

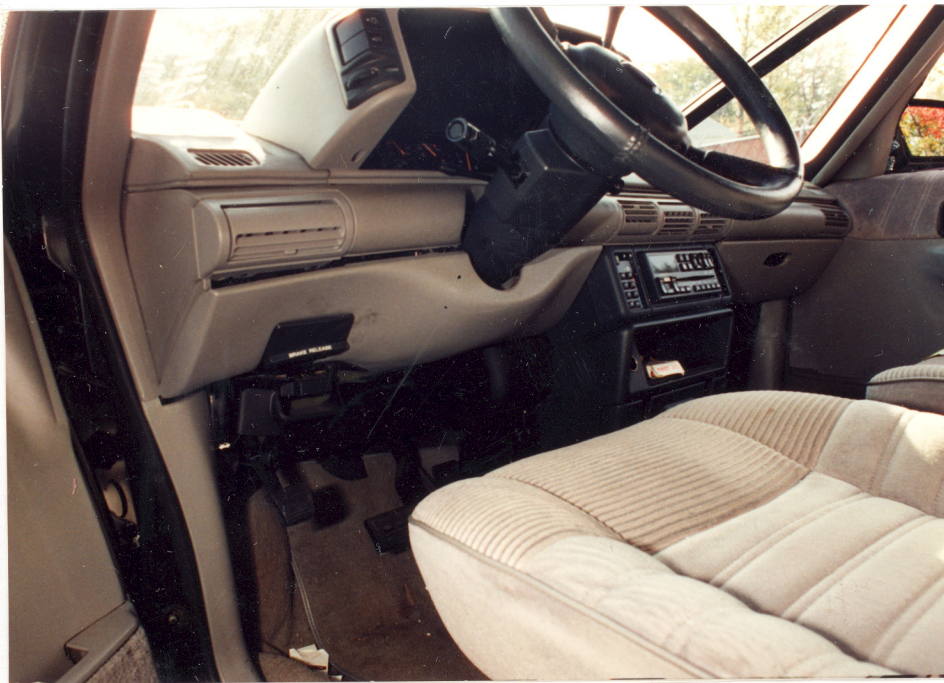
81. Interior view of driver knee contact to the lower instrument panel.
